NACA RM E53G02

PRELIMINARY INVESTIGATION OF SEVERAL ROOT DESIGNS FOR
CERMET TURBINE BLADES IN TURBOJET ENGINE

II - ROOT DESIGN ALTERATIONS

By A. J. Meyer, Jr., G. C. Deutsch, and W. C. Morgan

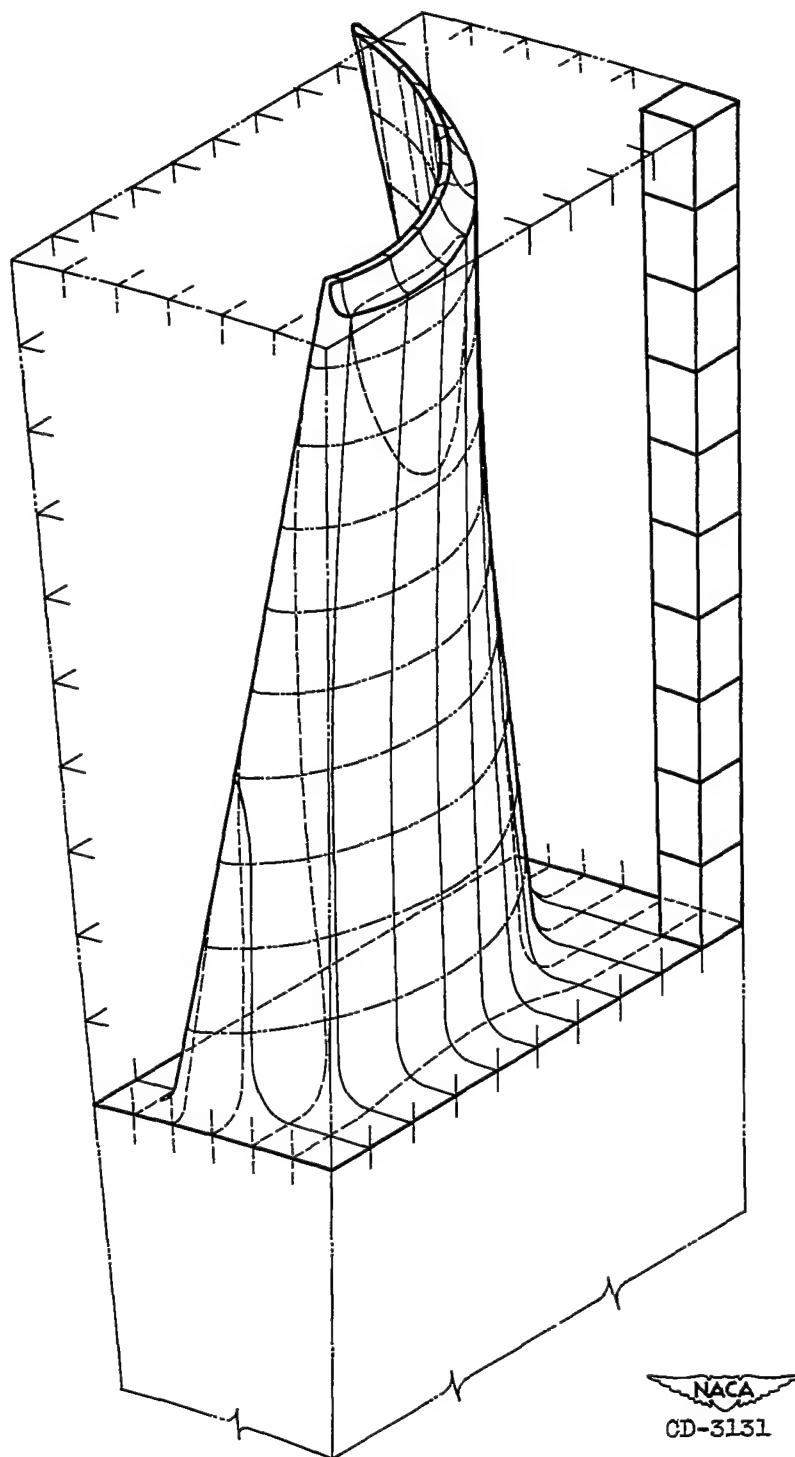
Figure 9. - Sketch showing airfoil divisions for computation.

Calculation procedure. - The airfoil span or length was divided into 10 sections. The profiles of the sections were drawn to five times the size. The base profile was subdivided into small squares $1/2$ inch on a side (0.1 inch on a side at actual blade size.) All other profiles were correspondingly subdivided into rectangles $1/2$ inch in the direction of the turbine wheel axis and slightly greater than $1/2$ inch in the tangential direction. The correction in tangential distance is due to the increase in chord length of a radial segment as the radial distance increases, as sketched diagrammatically in figure 9. The volumes of the small airfoil pieces between corresponding rectangles of each station were calculated and totalled. The centers of gravities and the radial distances of the resulting long thin radial columns were computed to permit calculation of the centrifugal force acting on each square of the base airfoil profile due to its respective column.
